Design Fixes for Ramsey Electronics RDF Products

Ramsey FHT-1 SlyFox

Ramsey DF-1 Foxhound

DF-1 Foxhound Updates

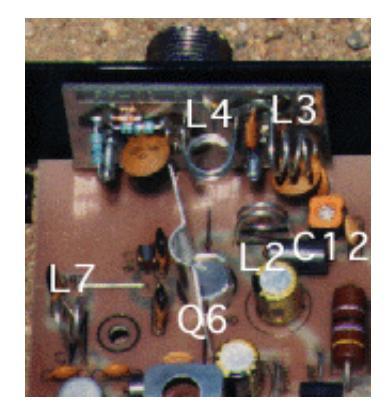
The SlyFox's harmonic filter is on a separate board that mounts at right angles to the main board. The photo was taken before L2 and L4 were spread to 8 TPI.

The Ramsey manual instructs builders to wind four coils (L2, L3, L4, and L7) on a supplied 5/16X20 bolt and then unscrew the coils. This gives them 20 turns per inch spacing (page 16, steps 84 and 85). As part of tune-up, the manual instructs to spread or compress L3 and L7 to maximize output power (page 25, step 10), but no instructions are given for L2 and L4. However, it turns out that all four coils must be expanded to about 1/8 inch turn-to-turn (8 turns per inch) as a starting point for tuning if the low-power/high-harmonic mode is to be avoided.

By expanding L2 and L4 to 8 turns per inch and then fine-tuning all four air-wound coils and and trimmer C12 very carefully with a spectrum analyzer, I was able to get about 4.5 watts out at 13.8 VDC supply, with all harmonics better than -50 dB and a much cooler final transistor.

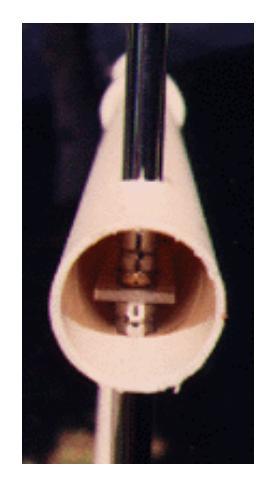
Telescoping whips screw into circuit boards at the ends of the antenna crossarms. On my unit, the crimping at the bottom of the whips loosened soon after I began using it in the field. The whips turn freely even though the holding screws are tight in their nuts. Could this be the cause of intermittent indications?

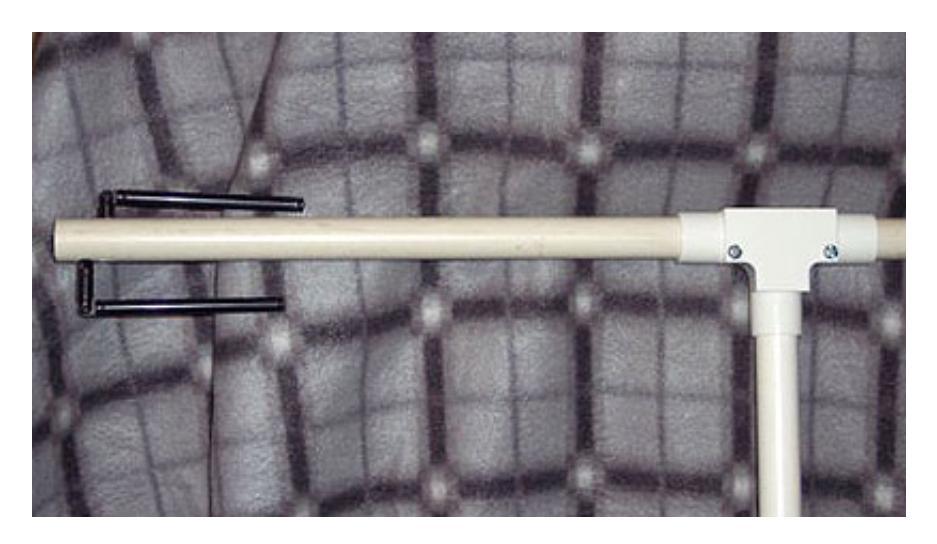
The photo above is one side of the 'T', showing the inspection plate and folded antennas. The photo below is rear of the unit showing the battery box mounted using existing screws for DF1, which were long enough to pass through tubing and battery box case. The battery box holds a battery pack with 8 AA rechargeable batteries.

I bought a DF-1 kit from a ham store here in the UK. I had a similar problem with antennas in that the method of fitting was poor, so I decided to fit them a different way. Instead of plumbing tubing, I used electrical conduit tubing which has a thicker wall and does not flex like the plumbing type. The 'T' piece is of the inspection type with a plate that can be taken off. If there is ever a problem with the small PC boards, you do not have to mess about trying to access them. You simply unscrew the small inspection plate.

When fitting my antennas, I drilled the holes all the way through with the diameter just large enough for the screw to pass through. Then on the side where the antenna passed through, I opened up the holes to this diameter. When fitting the antenna, you place it in the hole and push the small PC board across to the opposite side. Using a small magnetized screwdriver, you then run the small screw into the base of the antenna and repeat the process for all four antennas.

When fitting my antennas, I also used locking washers. The antennas supplied with my kit do not have the crimped bases. They are solid section, drilled and tapped, and have a joint at the base which allows them to bend over. So by fitting them my way, I was able to line them up with the 'T' section so that when not in use and for storage in the trunk of the car they can be folded over and be parked parallel to the tube and out of harm's way.
